420 SEL 1991 Before Treatment

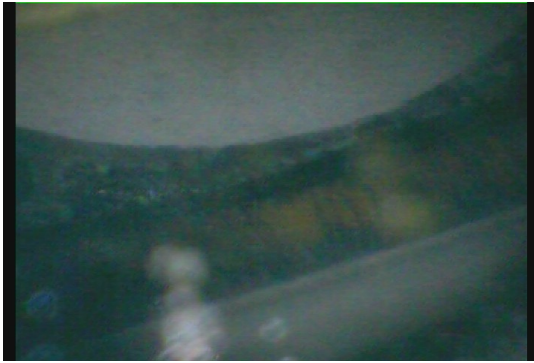
Valve

“Inspection confirmed crucial performance degrading carbon build up. Pictures show this carbon build up especially in the areas of the intake valve and the piston crown. Some carbon and discoloration or dulling was also noticed on the cylinder walls.”
